VEGETATION AND ENGINEERING STRUCTURES IN FLOOD AND EROSION CONTROL

Reed W. Bailey and Otis L. Copeland

INTERMOUNTAIN FOREST & RANGE EXPERIMENT STATION

September, 1961

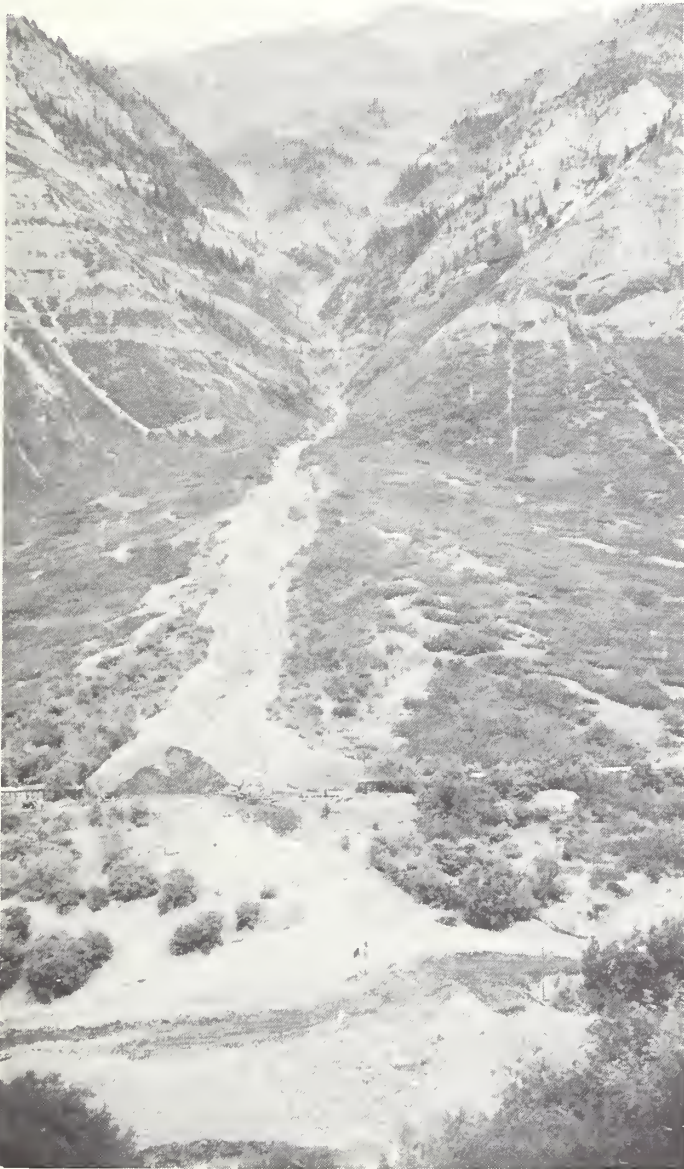
Figure 2.--A. Morris Creek watershed, Utah, north-facing basin occupying 167 acres whose average slope is 48 percent with extreme gradients of more than 80 percent. Precipitation averages 30 inches annually which is completely infiltrated. Dense vegetation provides protection against erosion. Sediment production from this watershed is only 0.0025 acre-foot per square mile per year and represents a low geologic norm.

Also essential to the formulation of any flood and erosion control program through forestry and engineering is an understanding of the relation between current flooding and erosion to the geologic norm (1, 3). Watersheds with their soil and plant mantle, topography, and streamflow characteristics have been inherited from the geologic past. Their streams exhibit great natural variation in erosion and in flood behavior. Some streams are usually clear and flow with a relatively constant volume, but the regimen of other streams is marked by great variance in volume and time of flow and vast differences in sediment content. Each stream is the resultant of such normal factors and forces as climate, topography, geology, and the soil and plant mantle. All these factors and forces have operated through the ages to give rise to definite land forms, specific soils, vegetation complexes, and characteristic stream channels, streamflow, and sediment loads. Erosional processes at varying rates on the watershed slopes and in the channels are also part of the norm. We know, for example, that erosion is proceeding so slowly in some areas that soil is being formed and accumulated more rapidly than it is being removed. Streams from such areas carry only negligible loads of sediment. We know, too, that in other areas climatic and geologic conditions limit soil formation, plant growth, and fixing of the land surface. From these drainages runoff has always been rapid and erosion pronounced, giving rise to muddy and highly fluctuating streams. Moreover we know that between these extremes are all gradations of watershed conditions and sedimentation rates. Variations in sediment production in relation to watershed conditions are shown in figure 2.

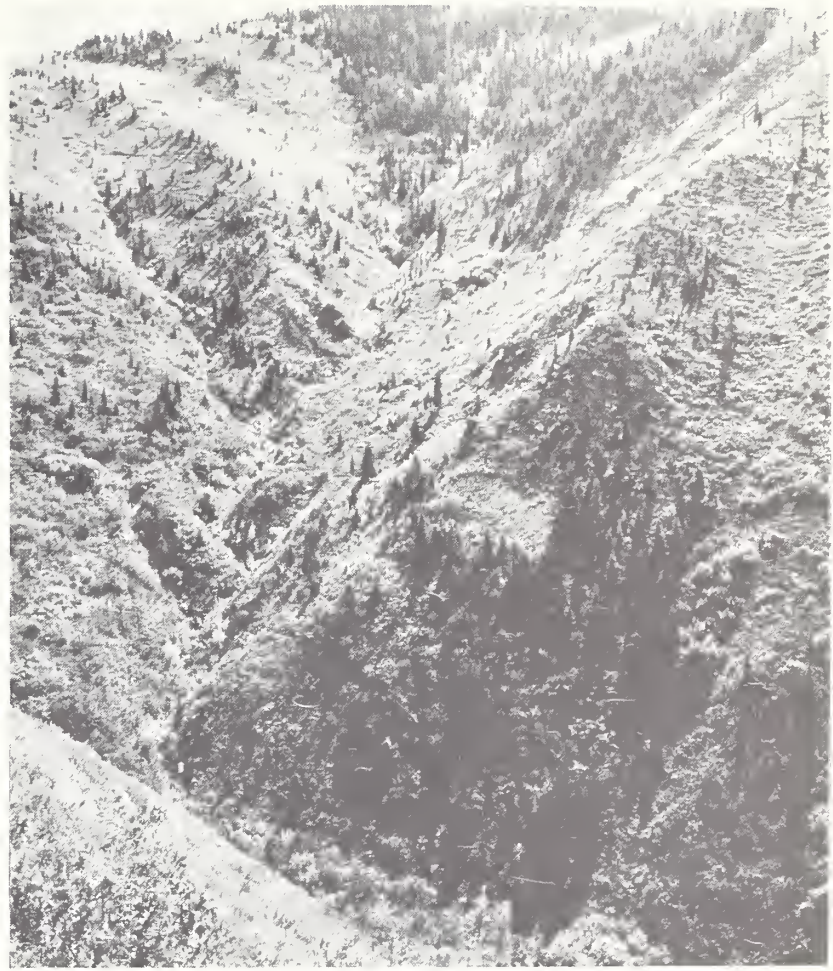
Figure 2.--B. Lost Creek watershed, Utah; 85 percent of area comprised of steep barren slopes. Active erosion and periodic flooding are characteristic of this basin giving it a high geologic norm. Small islands of soil protected by vegetation show no evidence of overland flow and erosion. Erosion removes soil material as rapidly as it forms from unvegetated slopes.

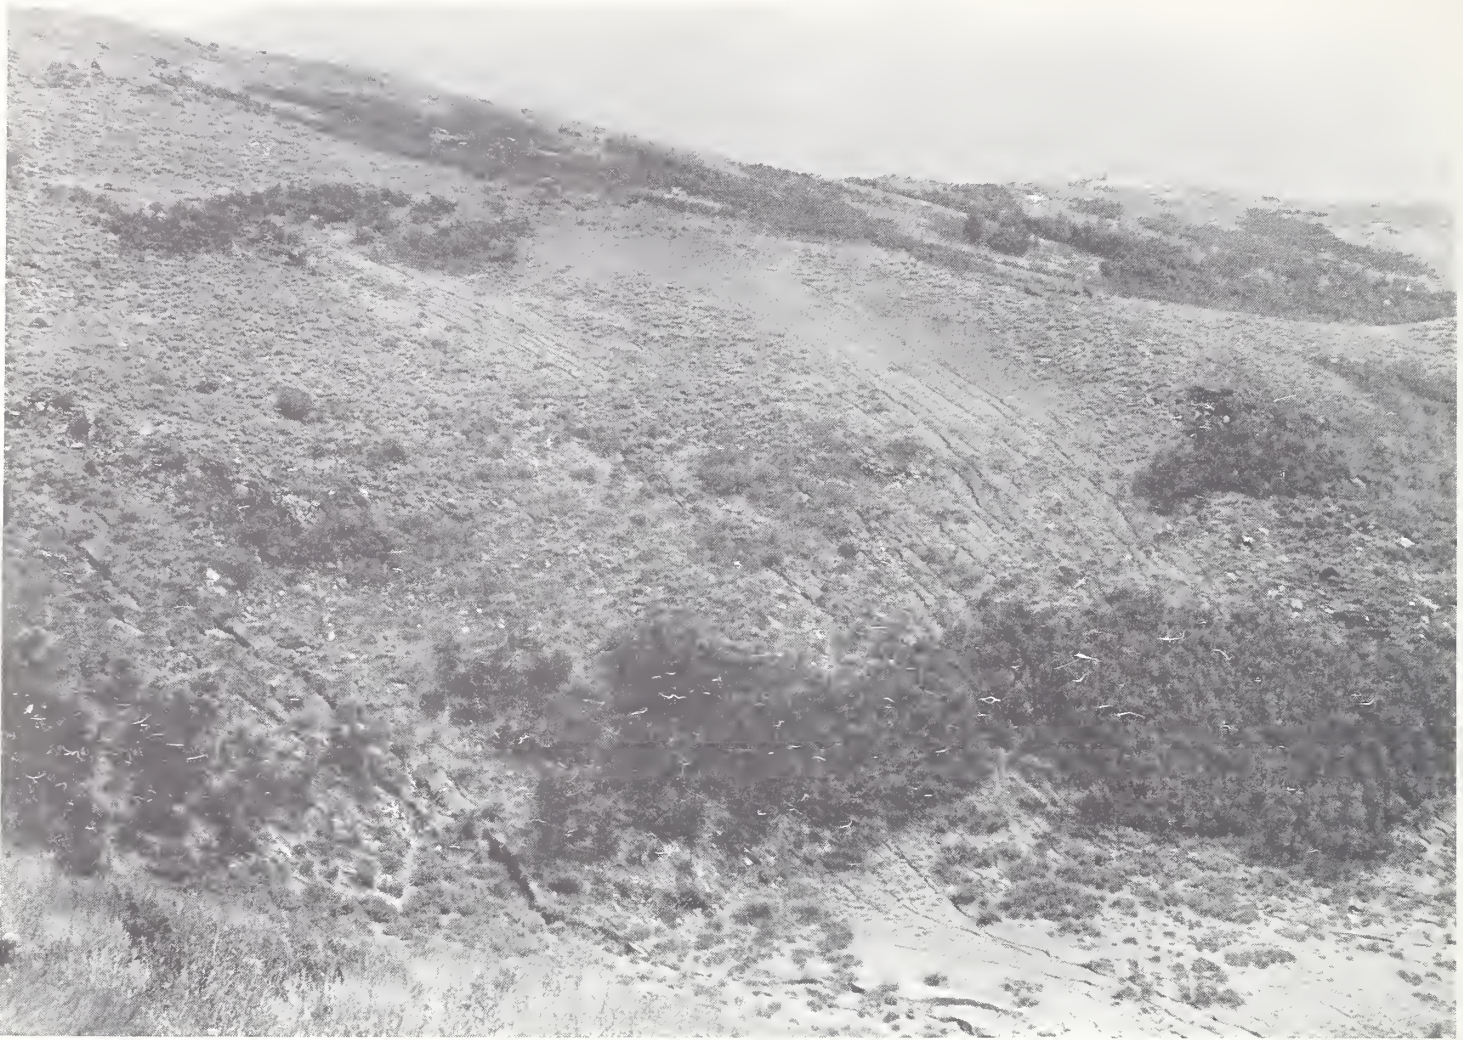
Figure 5.--Moderate slopes in the head of Ford Canyon, with small areas denuded and gullied. Note how gullies start at the upper edge of bare spots.

By following the freshly scoured channels up from the valley, the sources of these floods were found to be areas varying from less than one acre to a few acres in extent in the headwaters at elevations of 7,500 to 9,000 feet; on these flood-source areas the plant and litter mantle had been drastically reduced by very heavy overgrazing and to some extent by fire. That these areas were the source of the flood runoff was evidenced by an efficient system of gullies freshly cut in the soil mantle. In the aggregate these deteriorated and gullied flood-source areas covered less than 10 percent of the mountainous catchments (fig. 5).

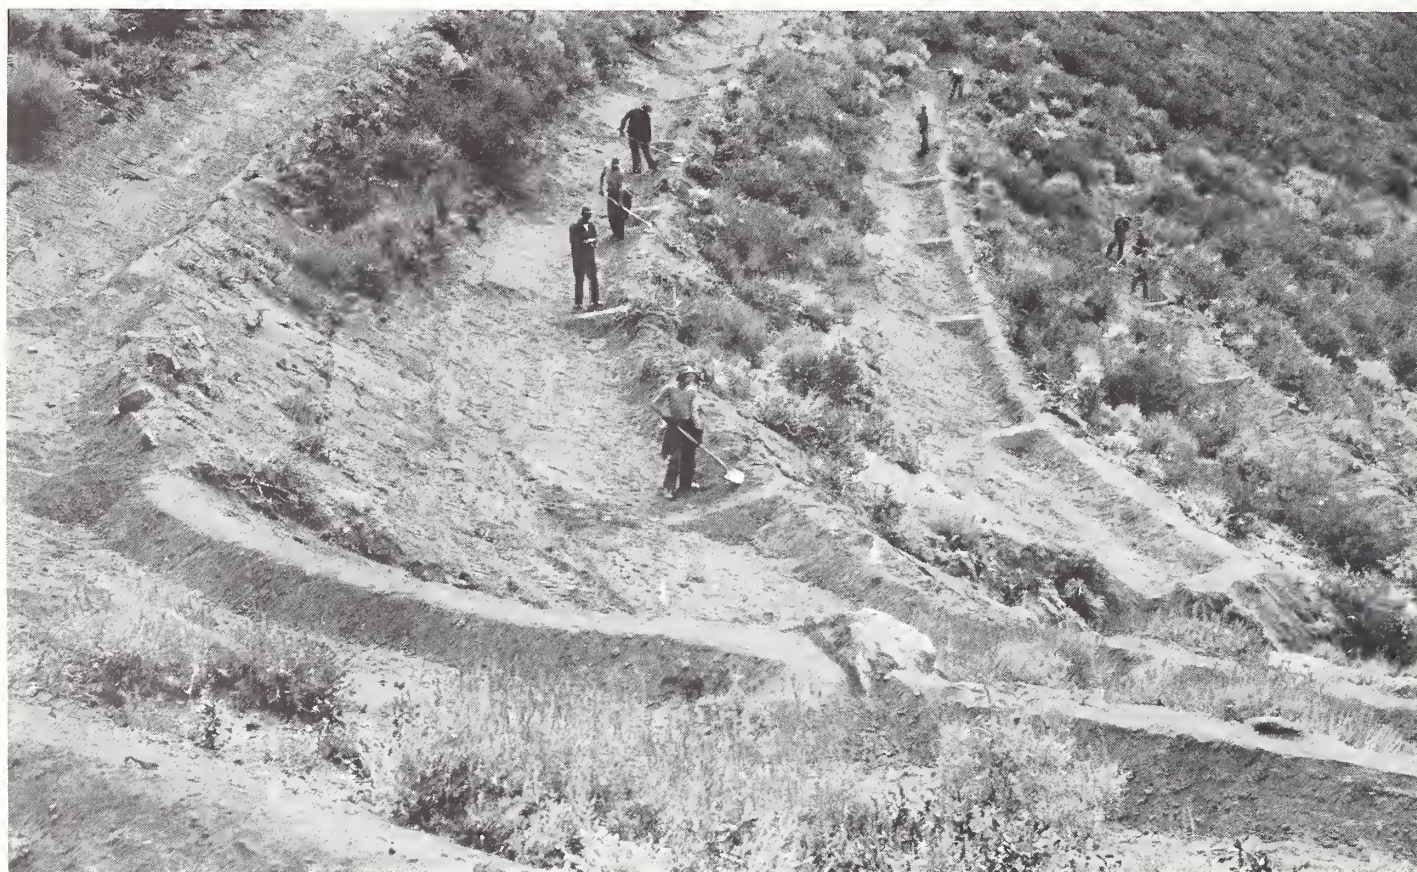
Figure 7.--Contour trenches constructed on the Davis County Experimental Watershed. They were designed to hold 1.50 inches of rainfall. Note spacing of about 25 feet and the small check dams being finished by hand.

The contour trench system as initially developed and applied successfully on the Davis County Experimental Watershed in northern Utah consists of a series of zero-grade trenches spaced sufficiently close to hold 1.50 inches of rain (2). Small check dams were constructed across the trenches to segment them into about 200 compartments per mile. These dams or "equalizers" were slightly lower than the fill dike; thus water could flow from one compartment to another without overtopping the dike (fig. 7).

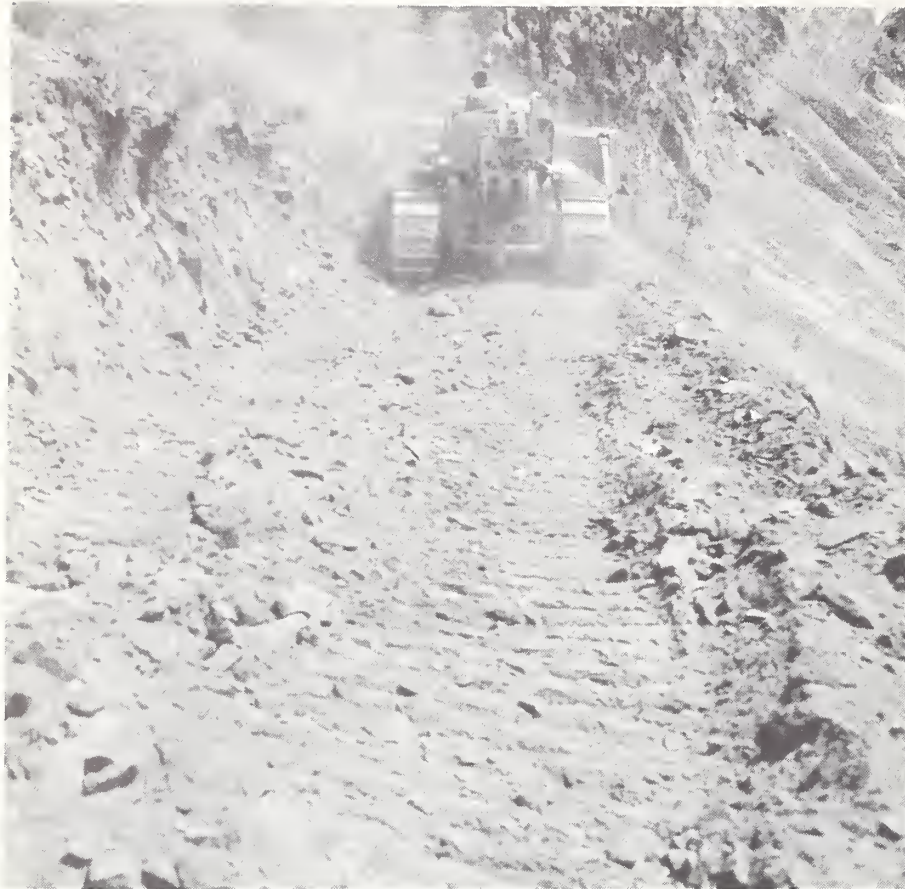
Figure 8.--A. On steep terrain, the first phase of contour trench construction is building a road the width of the blade on which the tractor operates. The vertical wall is then backsloped.

Trenches are located on the contour, keeping the interval rather constant (fig. 8). The most economical construction is obtained by using the largest types of crawler-tractors equipped with dozer blades. Costs per acre vary according to many circumstances, but a reasonable cost of trenching and reseeding is \$40 to \$50 per acre on moderate slopes; but on steeper slopes requiring insloping trenches, costs range from \$60 to \$100 per acre.

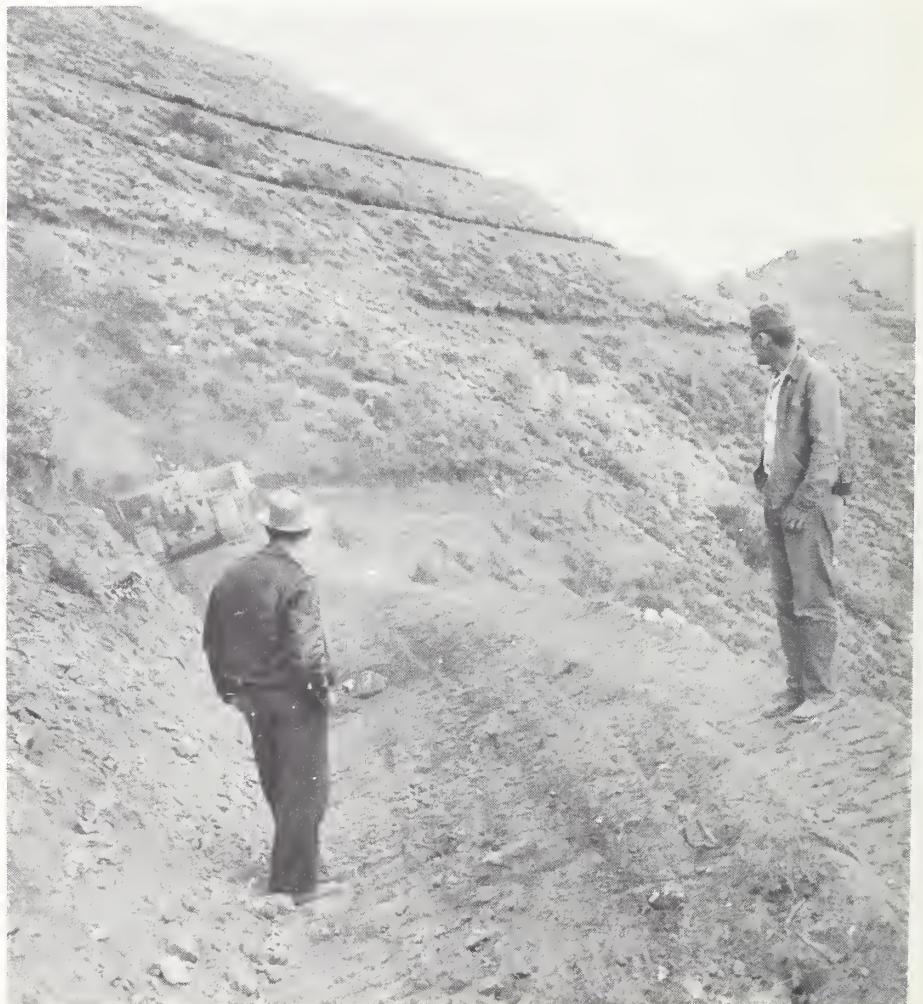
Figure 8.--B. Spill material from backsloping is pushed to the side to form the trench dike and is packed by the track of the tractor. This trench, on a 70-percent slope, is complete except for cross-dikes, which are formed by dipping the blade as the tractor backs out.
